Manhole Inspection Summary

Manhole # S15MM_015MH

Insp Date: **3/4/09 2:21 PM**

Location Address: **CAMPUS OF COPPIN STATE**

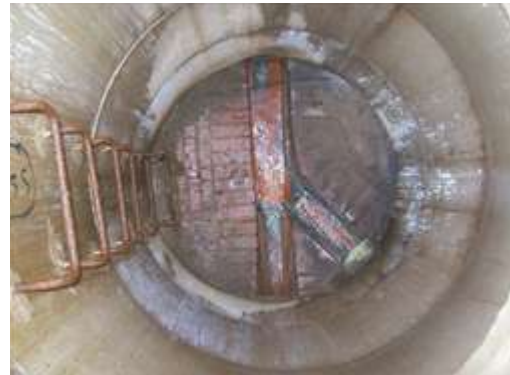
Top View

Count: **6** Missing: **0** ☒ **Corroded**

corroded steps

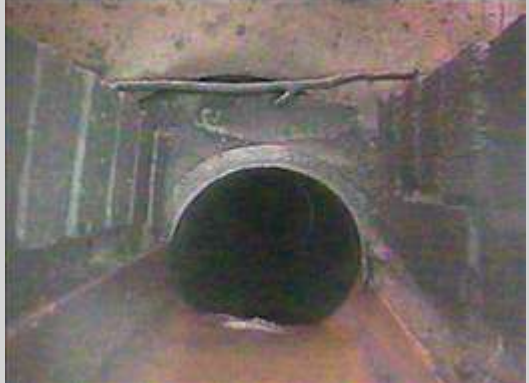
12 O'Clock Outflow

8 in. Circular Gravity Sewer
Pipe Out @ 12 O'Clock

Pipe Material: **Clay** ☐ Pipe Lined

Invert Depth: **9.76** (ft.) Flow Characteristics: **Slow**

Deposits: ☒ None ☐ Mud ☐ Sludge ☐ Debris ☐ Grease

Infiltration: **None** Pipe Seal Cond: **Sound**

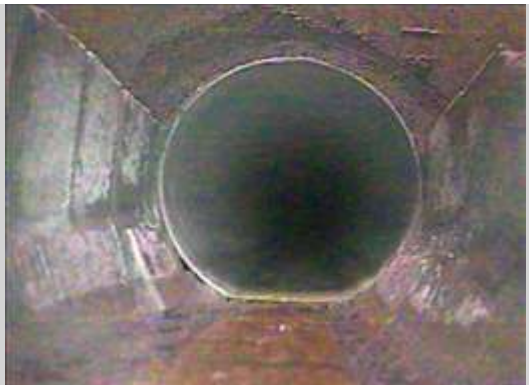
5 O'Clock Inflow

8 in. Circular Gravity Sewer
Pipe In @ 5 O'Clock

Pipe Material: **PVC** ☐ Pipe Lined

Invert Depth: **9.26** (ft.) Flow Characteristics: **Slow**

Deposits: ☒ None ☐ Mud ☐ Sludge ☐ Debris ☐ Grease

Infiltration: **None** Pipe Seal Cond: **Sound**

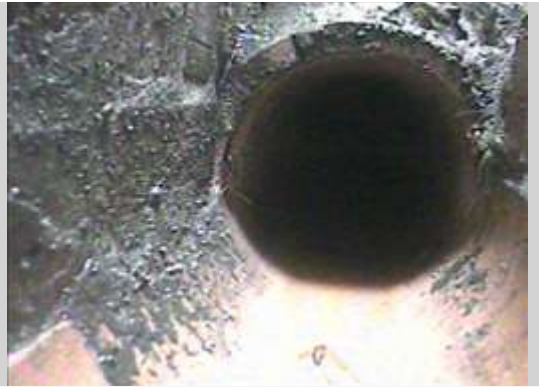
6 O'Clock Inflow

8 in. Circular Gravity Sewer
Pipe In @ 6 O'Clock

Pipe Material: **Clay** ☐ Pipe Lined

Invert Depth: **9.62** (ft.) Flow Characteristics: **Slow**

Deposits: ☒ None ☐ Mud ☐ Sludge ☐ Debris ☐ Grease

Infiltration: **None**

Pipe Seal Cond: **Sound**
